**Desert Home Inspectors, LLC.**  
**The First Step to Buying or Selling Your Home**  
2029 West Desperado Way  
Phoenix, 85085 AZ  
Tel 602-628-4941 Mobile 6026284941  
Web Email [andy@deserthomeinspectors.com](mailto:andy@deserthomeinspectors.com)

## Confidential Inspection Report

5905 E. Beryl  
Paradise Valley, AZ 85253

08/16/2017 12:30 PM - 05:30 PM

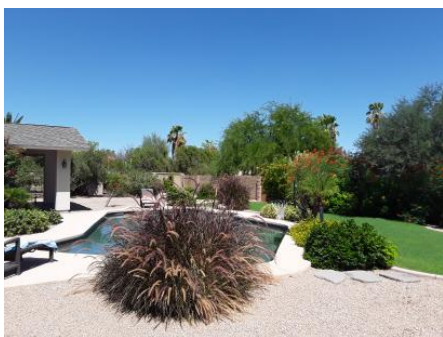
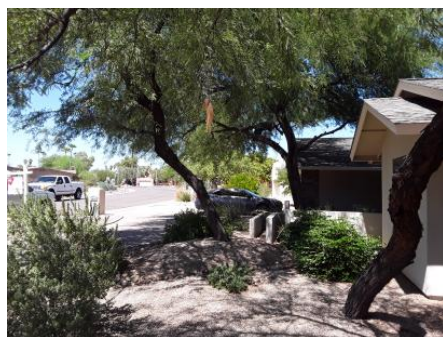
1.3 - I do not evaluate landscaping, but some of the trees, plants, bushes or shrubs need to be trimmed or pruned.

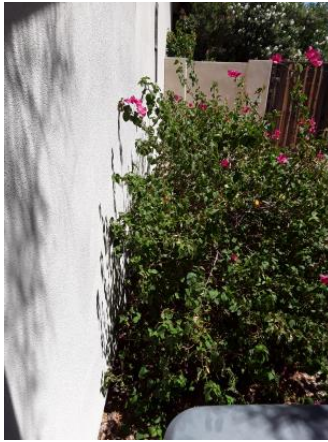
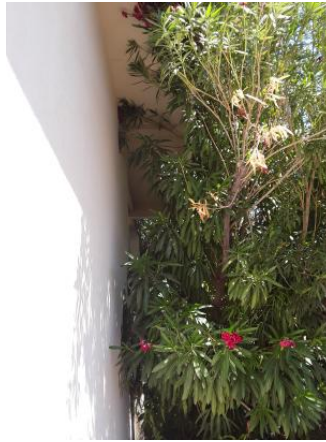
1.5 - Vegetation is encroaching on the structure, and should be kept a minimum of twelve inches away for the general welfare of the walls and foundation.

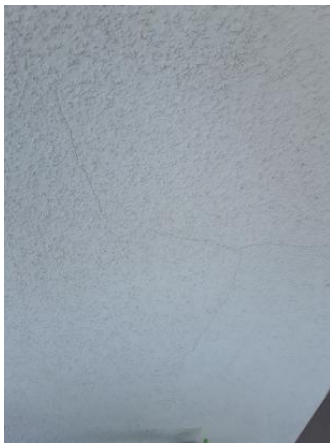
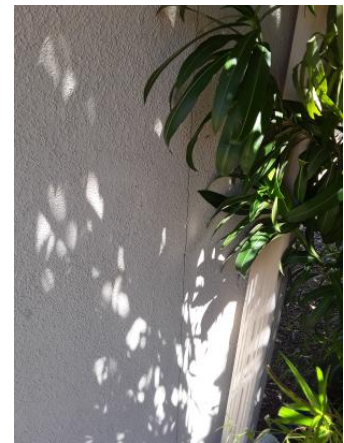
1.10 - There are typical shrinkage type cracks observed in the stucco, which you should view for yourself. All cracks result from movement, and are structural in that respect, but the vast majority of them have only a cosmetic significance. Most people do not realize that structures move, but they do and sometimes more or less continuously. Therefore, stress, settlement or shrinkage type fractures can reappear after they have been repaired, and particularly if they have not been repaired correctly. I recommend that all exterior cracks and gaps, if present, are properly covered or sealed to help prevent possible moisture or pest intrusion. However, you may wish to have this confirmed by an appropriate specialist. Most stucco homes are recommended to be repainted about every 10 years or so.

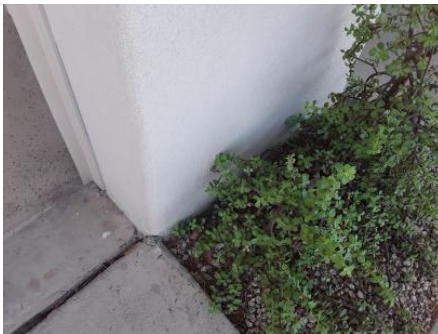
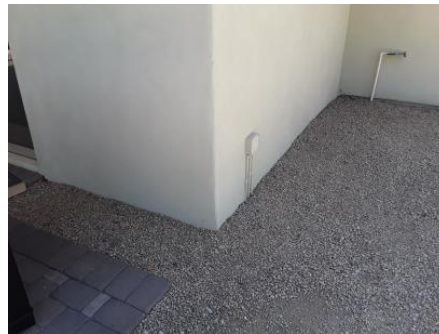
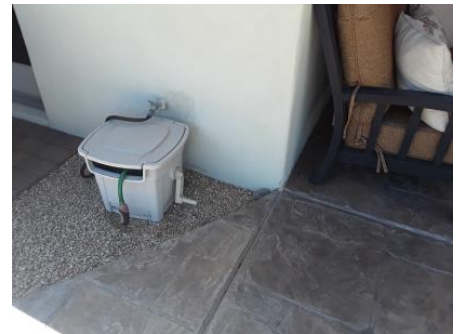
1.11 - The stucco extends down to the soil without the benefit of a weep-screed. Weep screed is a horizontal strip of metal that isolates the stuccoed house walls from the foundation and allows them to move independent of the foundation. This not only prevents horizontal cosmetic cracks that are commonly seen at the base of many stuccoed walls but also isolates the stucco from the soil and inhibits the wicking effect of moisture being drawn up into the stucco which in turn creates the flaking and peeling that is common on such surfaces. However, this was a common building practice for years and is very common.

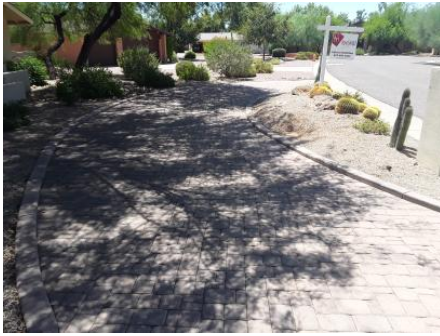
1.19 - The concrete paver driveway is in acceptable condition.

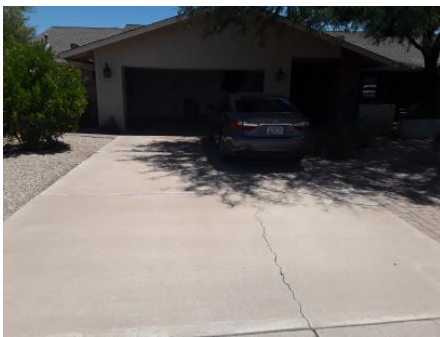
1.20 - There are predictable cracks in the driveway that would not necessarily need to be serviced. Further evaluation is recommended from a qualified contractor, for more detailed information, as you feel necessary.

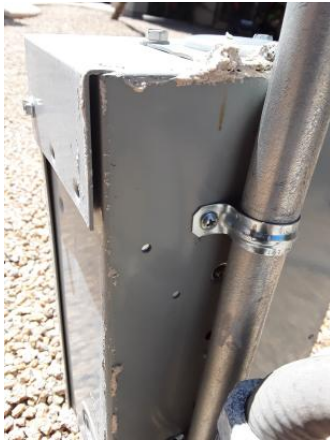
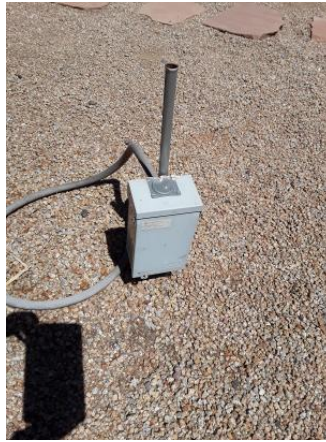
1.31 - There is an above ground spa breaker box located in the back yard. On the back of it is an open knock out. The knock out hole should be covered for safety reasons. The breaker located in this box is currently off.

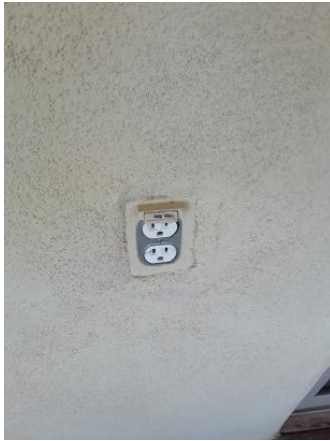
1.32 - A weather proof outlet cover is missing on the rear patio exterior outlet. I recommend replacement to protect the outlet from the elements.

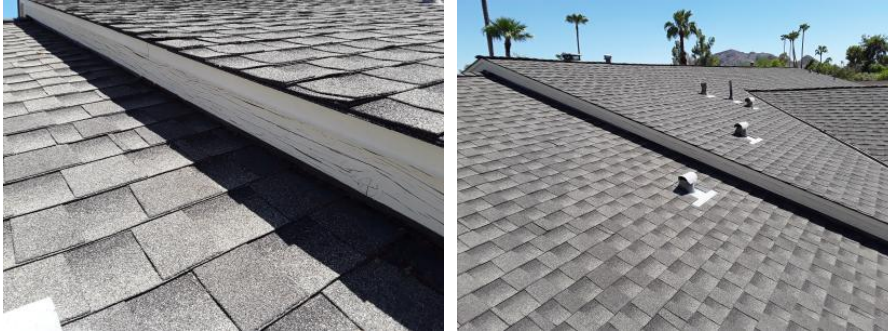
1.37 - Sections of the wood fascia board and/or wood trim areas are weathered and should be serviced soon to help prevent further deterioration.

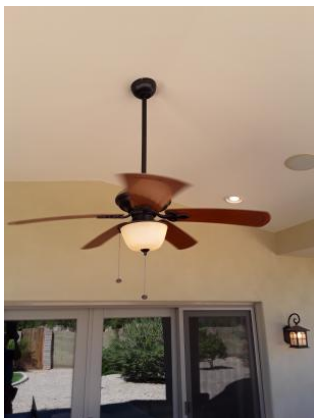
1.44 - The rear patio ceiling fan wobbles during high speed and may need service (Balancing). I recommend further evaluation from a qualified contractor as you feel necessary.

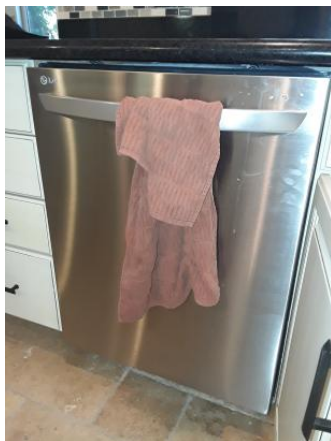
2.5 - The dishwasher is functional, completes an entire cycle, drains properly and no leaking was noted.

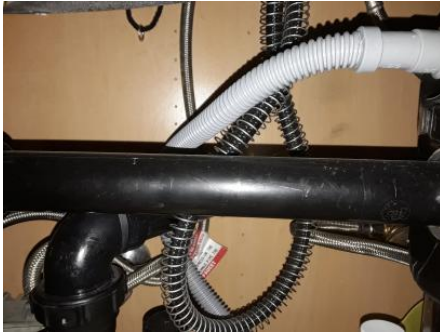
2.6 - The dishwasher does not have a high loop in the drain line at the garbage disposal and

one should be added. The drain line is recommended to be raised 4-6 inches above the garbage disposal inlet to create a high loop that should help prevent the possibility of contaminants back flowing from the disposal into the dishwasher.

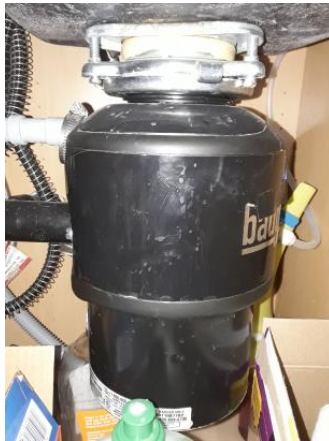
2.7 - The garbage disposal is very noisy and may have worn components . Further evaluation is recommended from a qualified contractor for service or replacement as determined necessary.

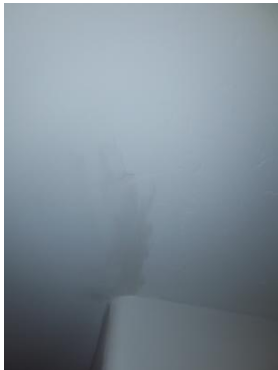
3.17 - Observed typical settlement type cracking on walls and ceilings.

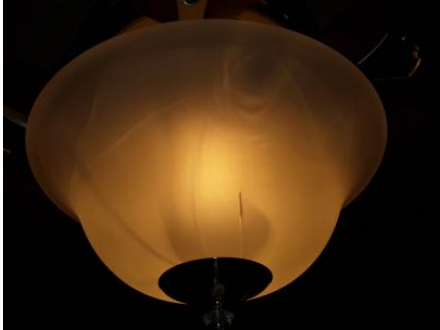
3.19 - The ceiling fan glass cover is cracked.

I recommend further evaluation from a qualified contractor for more information and service as determined necessary.

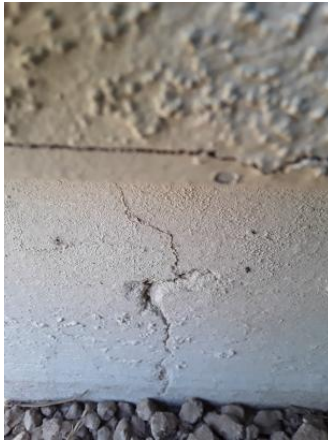
5.12 - There are minor cracks in some concrete stem walls of the slab foundation. These cracks are common and are not typically regarded as being structurally threatening. However, you should have a qualified contractor confirm this and especially if you are concerned or desire more detailed information. Evaluation is recommended within the inspection period.

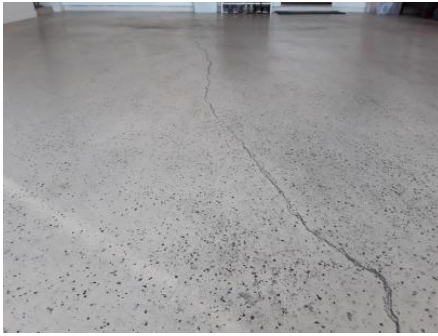
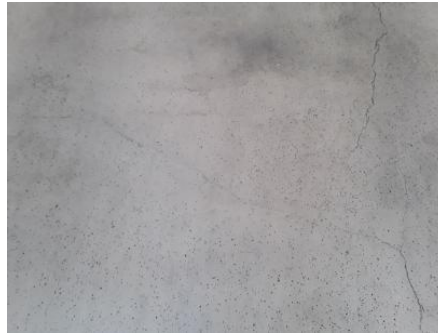
6.3 - The slab floor is cracked, but not load-bearing. Such cracks are common and result as a consequence of the curing process, ordinary settling, or the presence of expansive soils, but are not structurally threatening. We can elaborate, but you may wish to have a structural engineer confirm this.

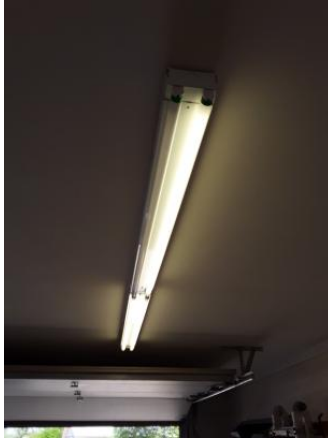
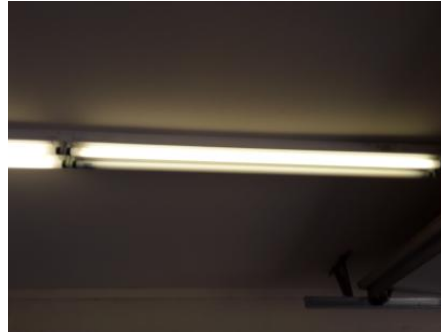
6.14 - The garage lights are functional and work on demand. Two bulbs appear to be not working.

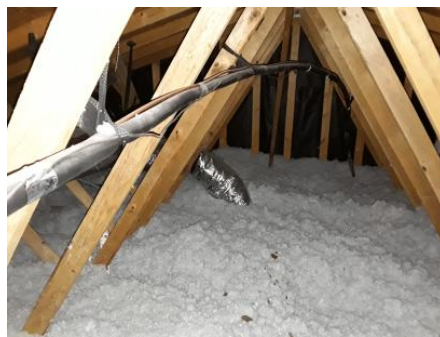
7.3 - The roof framing is in satisfactory condition. The roof framing consists of a wood truss type system, comprised of components called chords, webs, and struts that are connected by metal gussets nailed in place. Each component of the truss is designed for a specific purpose, and cannot be removed or modified without compromising the integrity of the entire truss. The lowest component, which is called the chord and to which the ceiling is attached, can move by thermal expansion and contraction and cause creaking sounds, which are more pronounced in the mornings and evenings along with temperature changes. Such movement has no structural significance, but can result in small cracks or divots in the drywall or plaster.

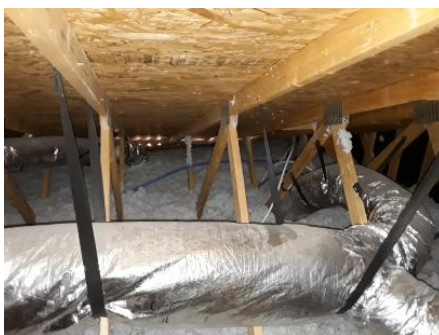
7.4 - The visible portions of the oriented strand board roof or OSB decking are in acceptable condition and should conform to the standards of the year in which they were installed.

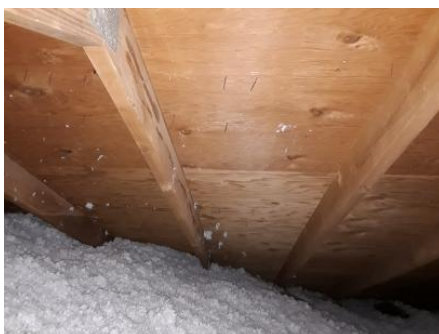
7.5 - The visible portions of the plywood roof decking are in acceptable condition and should conform to the standards of the year in which they were installed.

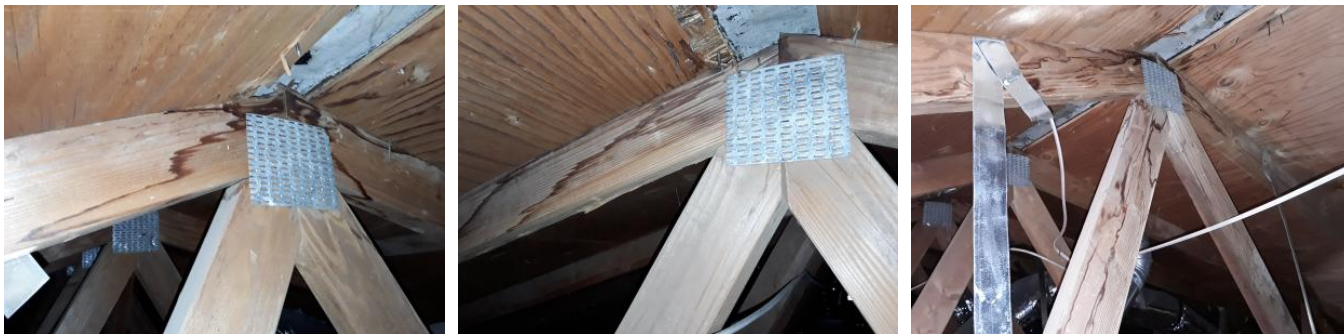
stains. This shows that moisture is getting through the ridge vent, probably during heavy rain storms, and you should consult with a licensed contractor about correcting this condition. This is important to help prevent moisture related issues. There were no signs of related moisture getting into the living areas of the residence during the inspection.

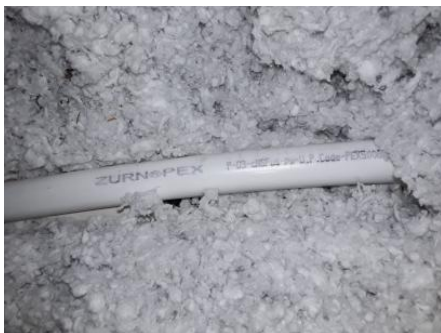
7.17 - The visible portions of the water pipes are in acceptable condition, but should be monitored because of their location. Leaks from pipes that pass through an attic can be soaked up by insulation, and are difficult to detect until significant damage is evident elsewhere.

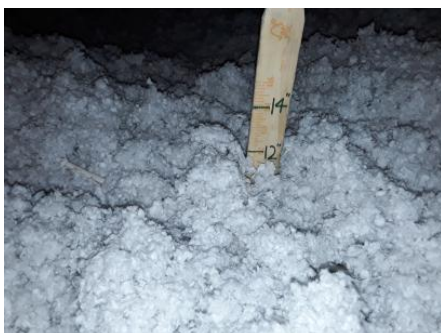
7.18 - The attic floor is adequately insulated with blown loose fiberglass, but not to a maximum standard. I observed approximately 12 inches in various attic floor areas which should provide over the minimum R-30 rating as required. (R-38) Insulation prevented viewing some attic areas.

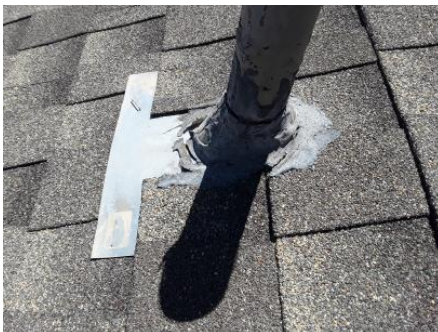
8.6 - The roof penetrations have been sealed with mastic, instead of conventional metal roof jacks, and will need to be monitored.

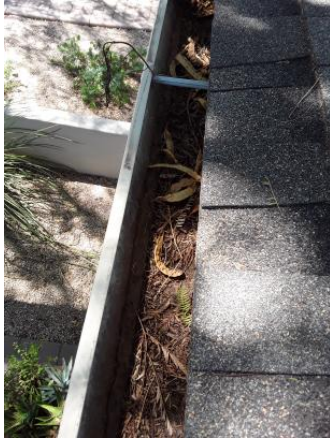
8.8 - The gutters need to be cleaned and serviced to drain properly. Located near front patio.

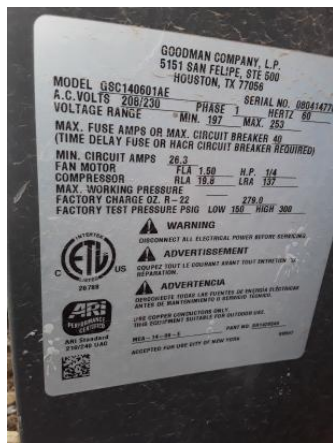
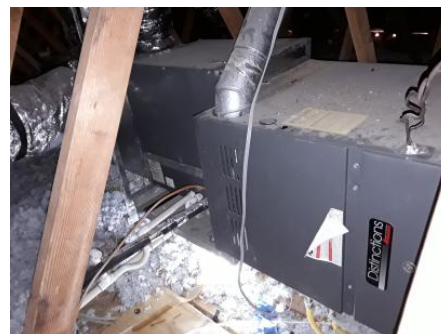
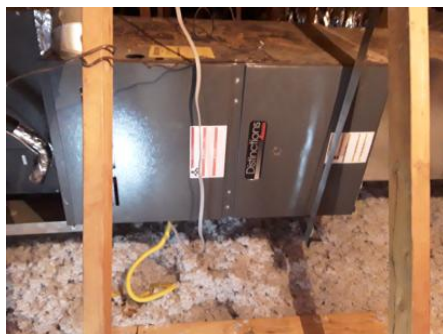
9.1 - Central heat and air-conditioning are provided by dual systems, consisting of two gas forced air furnaces (one 10 year old and the other 9 year old) with evaporator coils located in attic, and two electric 9 year-old, 8.5 total ton capacity, Goodman brand condensing coils located on each side yard. Electric cooling and gas heat.

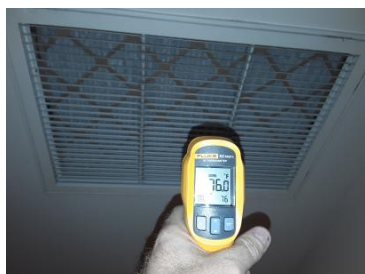
9.5 - The air conditioning systems both respond and achieve an acceptable differential temperature split between the air entering the system and that coming out of 20 degrees. Typically between 18 - 22 degrees. Actual temperatures measured were: 56 degrees at the air supply registers and 76 degrees at the return.

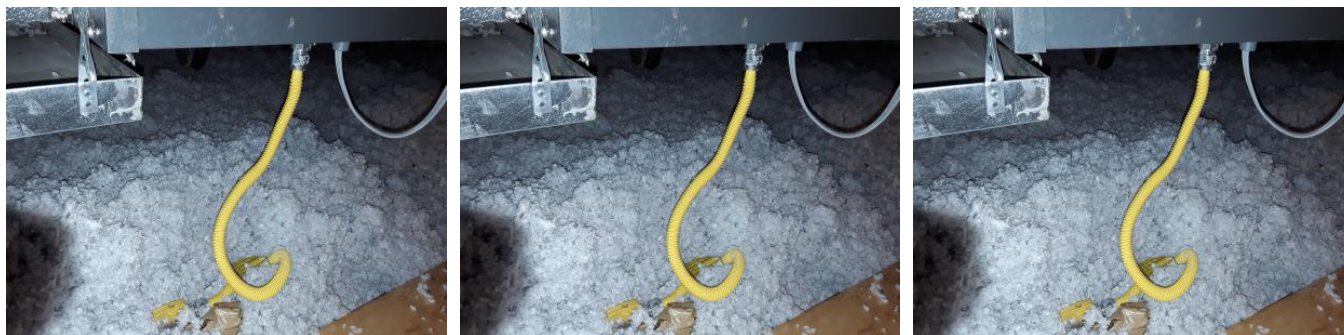
9.10 - The flexible gas feed line or lines to the furnace(s) doesn't have a drip loop or drip leg to catch debris in the gas line. I recommend further evaluation from a qualified technician or plumber for service as determined necessary .

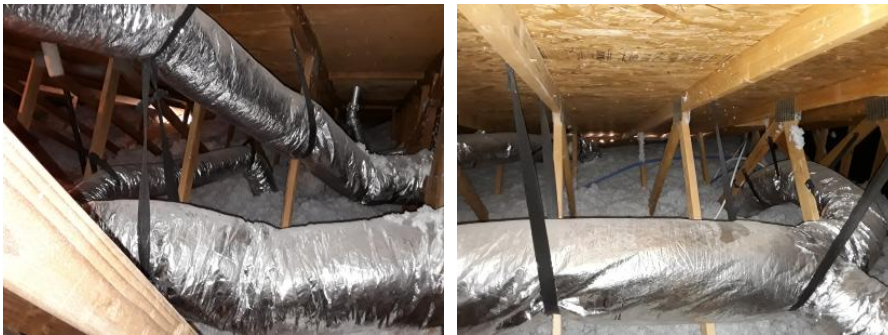
9.22 - The flexible ducts have no visible deficiencies. They are a modern, insulated, flexible type and are hanging properly with flexible fabric hangers.

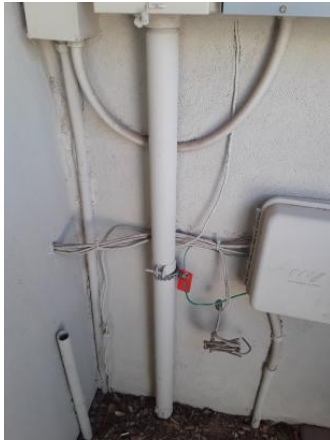
10.4 - The main conductor lines are underground or lateral service and in satisfactory condition. This is a characteristic of modern electrical services, but because the service lines are underground and cannot be seen, they are not evaluated as part of our service. I recommend contacting a qualified contractor for more detailed information.

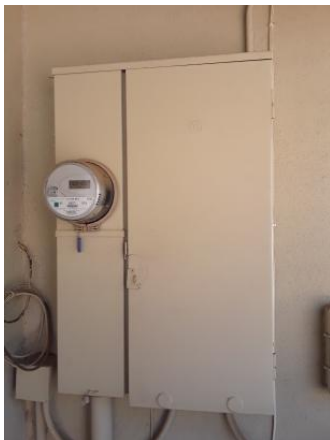
10.5 - The residence is served by a 200 amp, 120/240 volt GE brand breaker panel located in the left side yard.

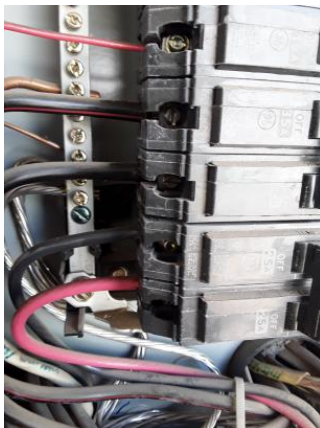
10.12 - There is aluminum wiring in the panel but only on the larger circuits such as: the a/c units.

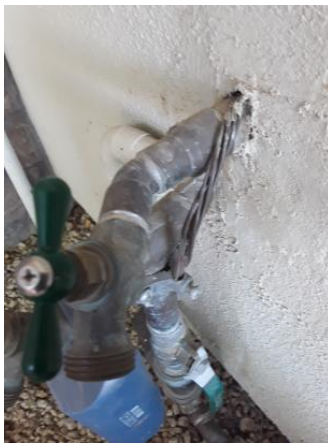
10.15 - The panel is grounded to a water pipe at the main water supply line.

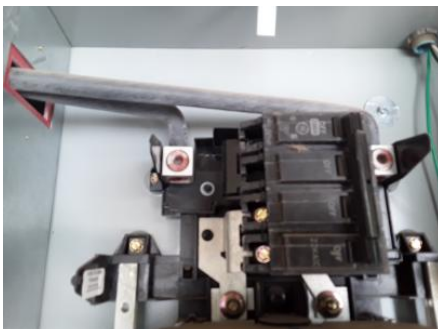
10.16 - The service conductor appears to be copper and is in satisfactory condition.

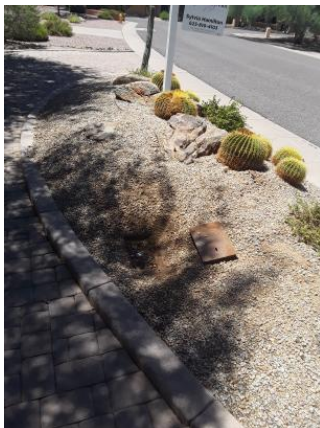
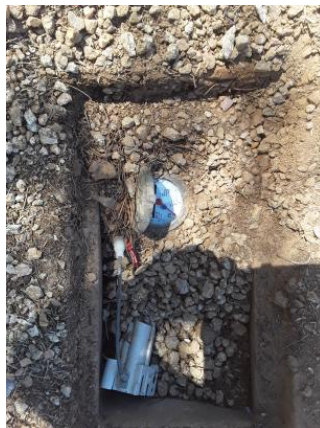
11.2 - The street or city water shut off valve is located in the front yard near the street under a cover. I observed it for a short while and noticed the meter/dial was not spinning or moving while no water was in use within the residence. This is a good indication there is no water leaking underground between the meter and the residence. However, this is not an exact determination and further evaluation from a qualified plumber is recommended, before the close of escrow, especially if you desire more information or are concerned about the possibility of an underground water leak. Following up with the water company is recommended so you are aware of potential normal water usage at the residence.

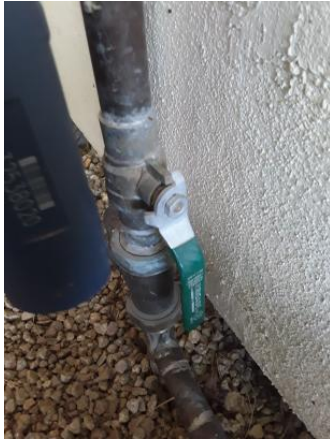
11.3 - The house water shut off valve is a ball type valve and appears to be in satisfactory and functional condition.

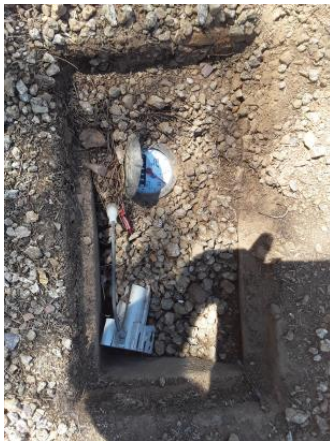
11.4 - The street water meter box is full of dirt and I was unable to view or access the meter during this inspection.

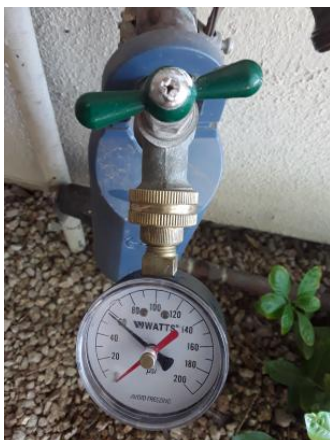
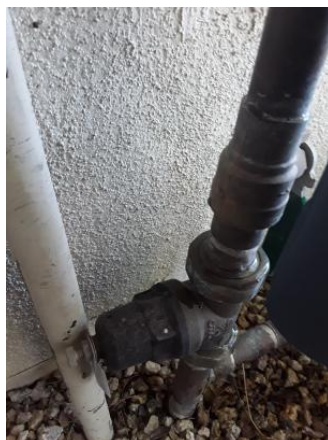
11.5 - A functional water pressure regulator is in place on the plumbing system near the main house water shut-off valve. The water pressure was measured at 60 PSI. Water pressure is considered normal between 50-80 psi.

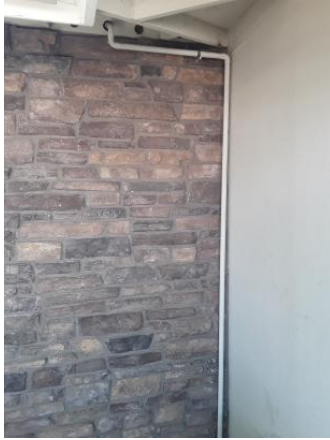
11.6 - I recommend securing the plumbing which goes up the brick wall on the front of the dwelling. It is located near the house water shut off valve. Securing the loose plumbing to the wall will prevent possible damage to the pipe which may result in leak in the future. I recommend further evaluation from a qualified contractor for more information and service as determined necessary.

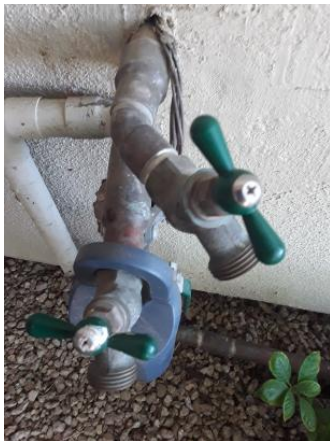
11.7 - The hose bibs that I tested are functional, but do not include anti-siphon valves. These valves are relatively inexpensive, are required by current standards. However, I may not have located and tested every hose bib on the property.

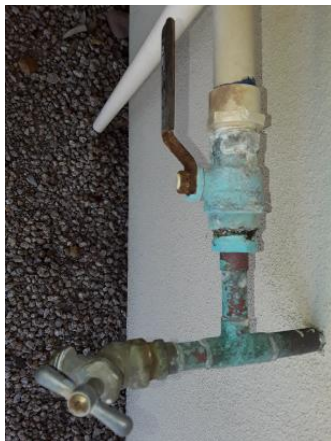
11.9 - The rear hose bib has a shut off valve which has evidence of corrosion. At one time it appears to have leaked but is not leaking right now. It needs further evaluation from a qualified contractor for service as determined necessary.

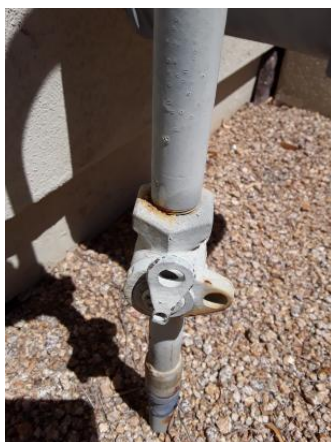
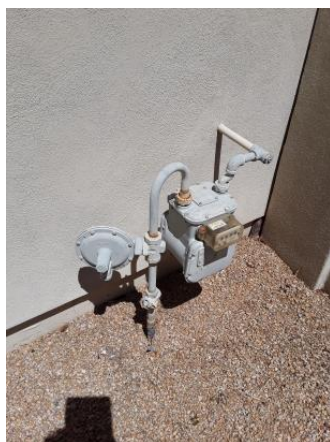
11.12 - The gas main shut-off is located in the right side yard . You should be aware that gas leaks are not uncommon, particularly underground ones, and that they can be difficult to detect without the use of sophisticated instruments, which is why natural gas is odorized in the manufacturing process. Therefore, we recommend that you request a recent gas bill from the sellers, so that you can establish a norm and thereby be alerted to any potential leak.

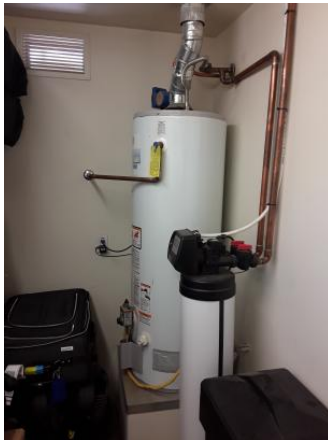
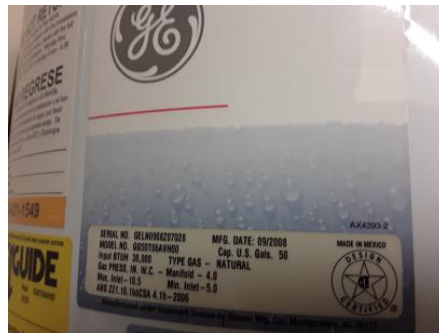
11.15 - Hot water is provided to this residence by a 9 year old, 50 gallon capacity, GE brand gas water heater located in the garage closet.

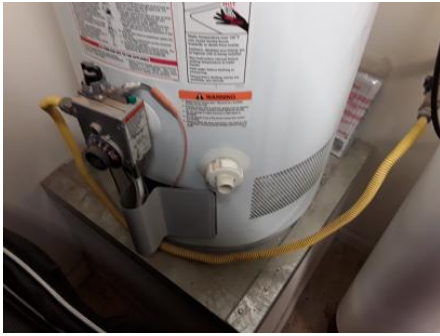
11.19 - The flexible gas feed line to the water heater doesn't have a drip loop or drip leg to catch debris in the gas line. I recommend further evaluation from a qualified technician or plumber for service if necessary .

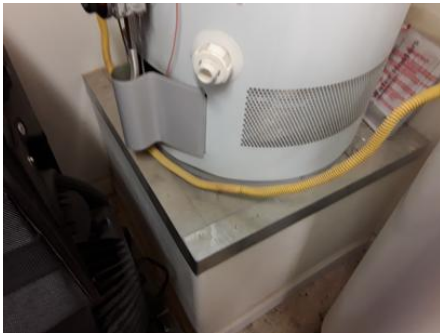
11.23 - The water heater is not equipped with a drain pan and a discharge pipe, which is designed to prevent water damage from a leak. Nevertheless, the water heater should be periodically monitored for any signs of a leak.

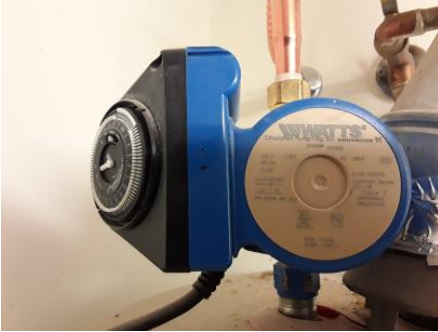
11.26 - The residence has a circulating system, or hot water loop, that I did not evaluate. However, the components of circulating systems have a shorter design-life than many other components, because their pumps often run continuously and because the abrasive action of moving water causes leaks, and particularly at fittings where the flow changes directions. I

recommend further evaluation of this system as you feel necessary.

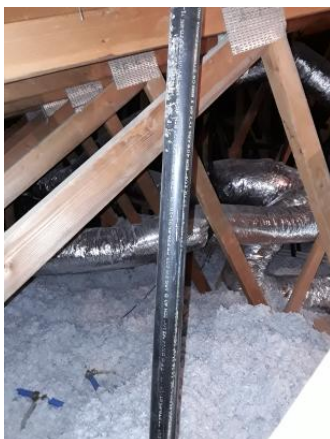
11.29 - The visible portions of the drainpipes are a modern acrylonitrile butadiene styrene type, or ABS.

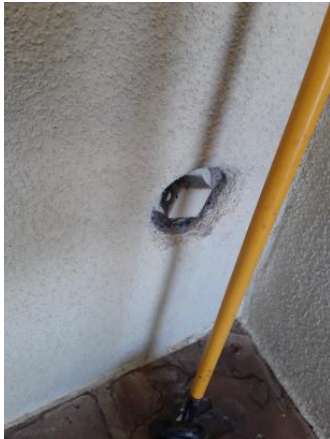
11.31 - There are plumbing cleanout wall access points located around the residence near bathrooms, sinks, toilets, the kitchen etc.

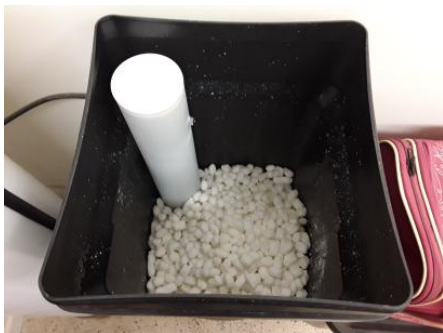
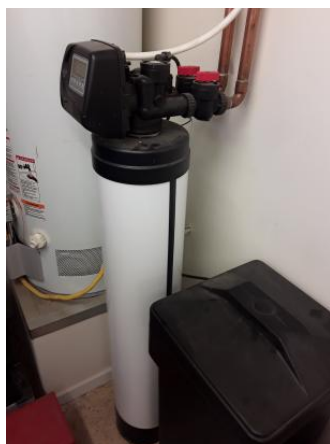
11.35 - Water treatment systems such as soft water systems were not evaluated during this inspection. They were viewed for obvious signs of leaking only. I recommend contacting the manufacturer or a qualified technician for further review or demonstration.

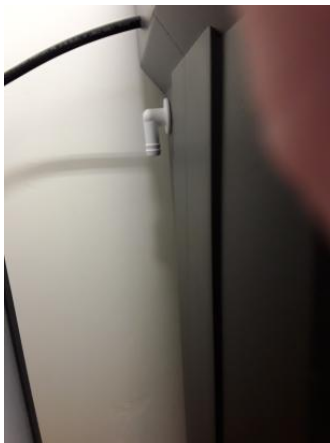
11.36 - The overflow drain line on the soft water system is not connected or installed. This could allow water to drain into the garage under certain circumstances. I recommend further evaluation from a qualified contractor for more detailed information and service as determined necessary.

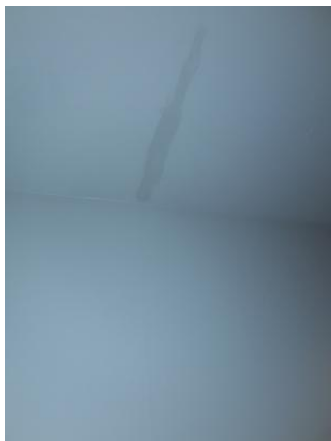
12.4 - Observed typical settlement type cracking on hallway walls and ceilings. These cracks appear to be caused by normal settlement. You should be aware that such cracks can reappear and typically if they are not repaired correctly. I recommend further evaluation from a qualified contractor for more detailed information, as you feel necessary.

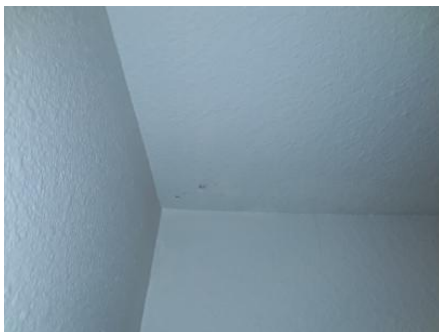
13.17 - There are minor and typical cosmetic issues on the walls or ceiling that you should view for yourself and repair or correct as desired.

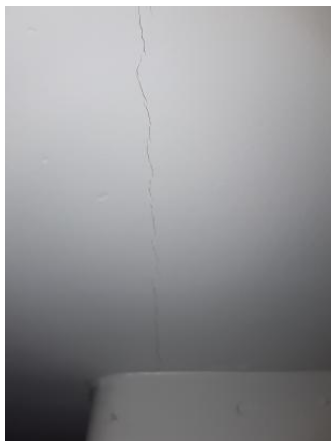
13.18 - Observed typical settlement type cracking on the bedroom walls and ceilings. It is common for these cracks to reappear, especially if they are not repaired correctly. I recommend you should view them for yourself and correct as desired.

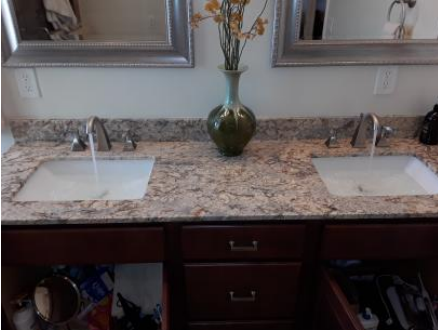
14.11 - The sink and its components are functional, water supply was verified and no leaking was noted. However, the valves beneath the sink are not in daily use and will eventually become stiff or frozen.

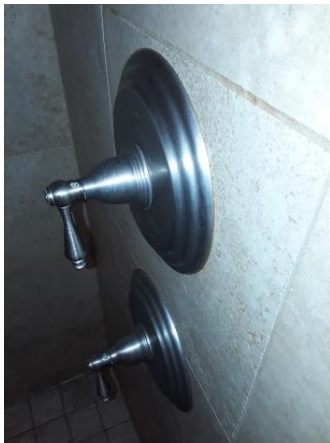
14.13 - I recommend caulking or sealing around shower valves and faucets etc to help prevent moisture intrusion behind or into the walls. Monitoring these areas is also recommended to help ensure an adequate seal is in place.

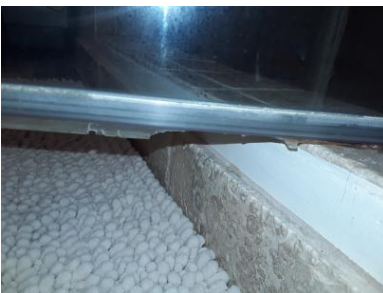
14.14 - The door sweep at the bottom of the glass shower door is damaged. This could allow water to escape the shower stall causing damage to walls and floors. I recommend further evaluation from a qualified contractor for more information and service as determined necessary.

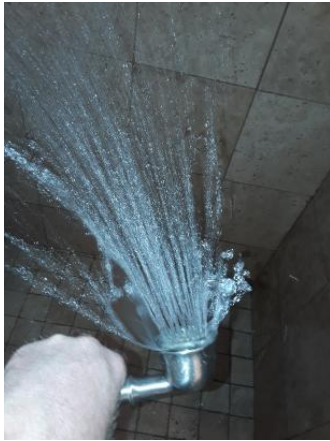
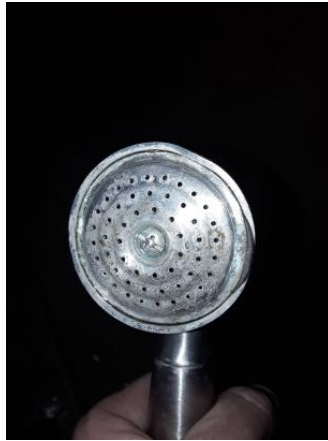
14.15 - The master bathroom shower wand leaks water out of the sides of the nozzle during use. It is designed to come out of the perforated holes only. It appears a gasket may have failed. I recommend further evaluation from a qualified contractor for more information and service as determined necessary.

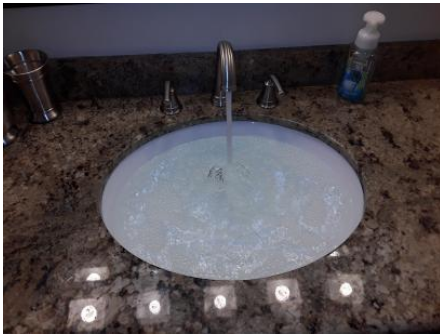
14.27 - The sink and its components are functional, water supply was verified and no leaking was noted. However, the valves beneath the sink are not in daily use and will eventually become stiff or frozen.

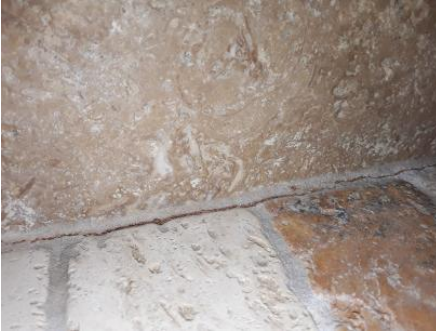
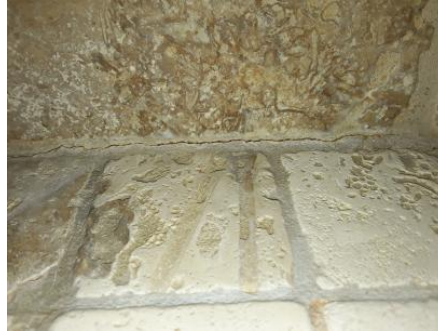
14.45 - There are open grout-joints where the floor meets the wall in the stall shower tiles that should be sealed to prevent moisture damage to the surrounding walls. Bathroom near garage door.

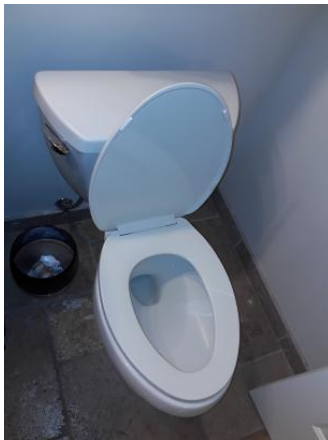
14.46 - The hallway bathroom toilet is functional, but loose on the floor and should be secured by a qualified contractor, for safety reasons and to prevent possible damage or leaking from around the toilet. Bathroom next to garage door.

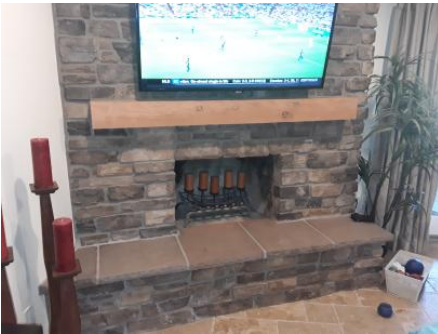
16.1 - There is a fireplace/chimney in the family room.

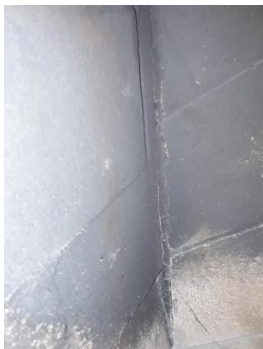
16.4 - There are small cracks in the chimney walls and grout joints which you may wish to have evaluated. However, such cracks are quite common, and rarely have any structural significance in a lined chimney. They can result from shrinkage, common settling, thermal extremes, moisture contamination, and the expansion and contraction associated with freezing and thawing,

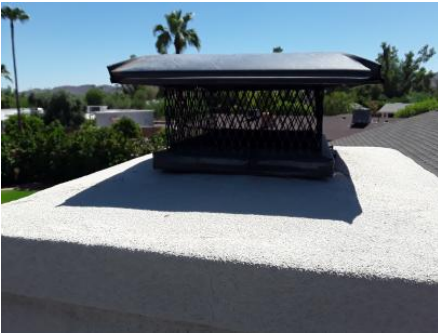
16.5 - The chimney has a functional weather cap/spark arrestor.

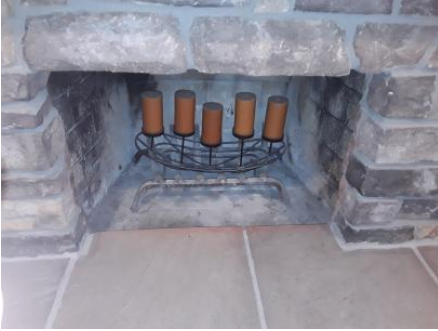
16.12 - There are no glass doors or a screen on the fireplace and one should be added for safety reasons. This is important to help keep anyone from touching the fire or very hot components within during or after use.
