## **Confidential Inspection Report**

### **Summary Report**

**5905 E. Beryl**  
**Paradise Valley, AZ 85253**

**08/16/2017 12:30 PM - 05:30 PM**

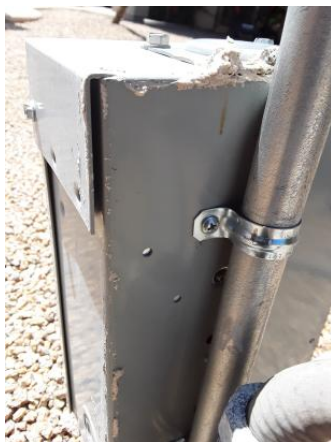
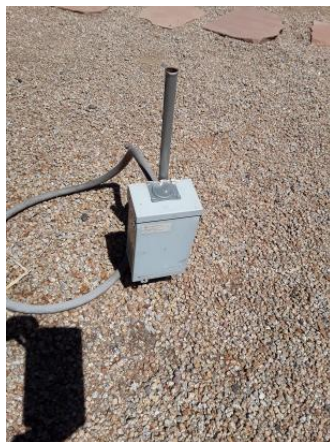
1.1 - There is an above ground spa breaker box located in the back yard. On the back of it is an open knock out. The knock out hole should be covered for safety reasons. The breaker located in this box is currently off.

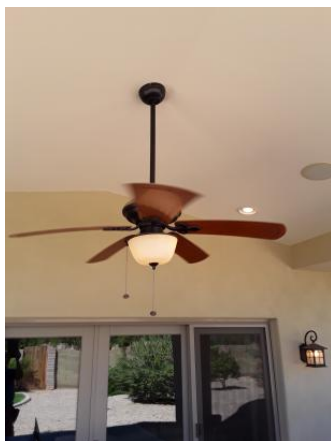
1.2 - The rear patio ceiling fan wobbles during high speed and may need service (Balancing). I recommend further evaluation from a qualified contractor as you feel necessary.

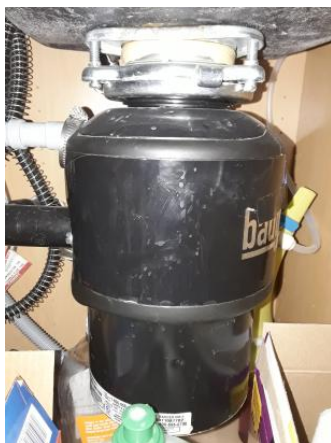
2.1 - The garbage disposal is very noisy and may have worn components . Further evaluation is recommended from a qualified contractor for service or replacement as determined necessary.

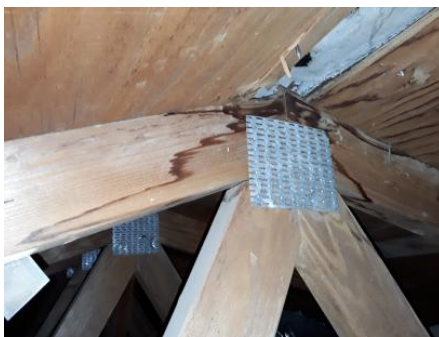
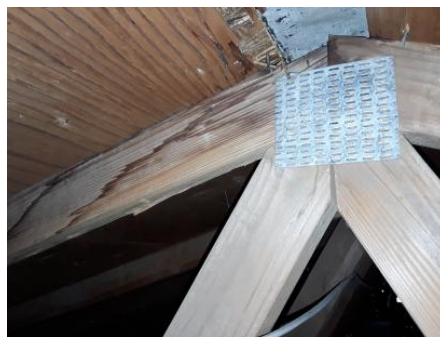
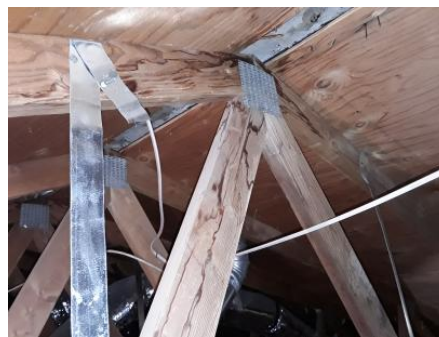
3.1 - There are signs of moisture intrusion and staining on the rafter peaks in the area above the attic air handler nearest the garage access. It is unknown if these are old or new stains. It was currently dry to the touch. You may want to ask the seller more information about these stains. This shows that moisture is getting through the ridge vent, probably during heavy rain storms, and you should consult with a licensed contractor about correcting this condition. This is important to help prevent moisture related issues. There were no signs of related moisture getting into the living areas of the residence during the inspection.

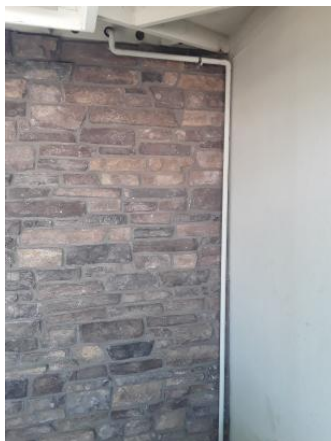
5.1 - I recommend securing the plumbing which goes up the brick wall on the front of the dwelling. It is located near the house water shut off valve. Securing the loose plumbing to the wall will prevent possible damage to the pipe which may result in leak in the future. I recommend further evaluation from a qualified contractor for more information and service as determined necessary.

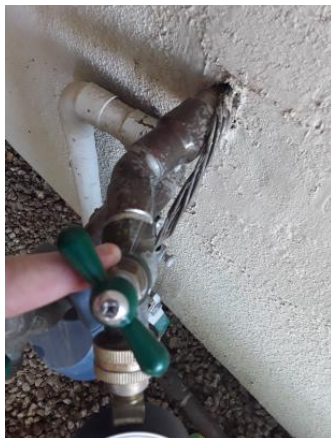
5.2 - A hose bib at the front of the property leaks "only when the water is on" and needs service from a qualified contractor as you feel necessary. The leak is between the nut and faucet body.

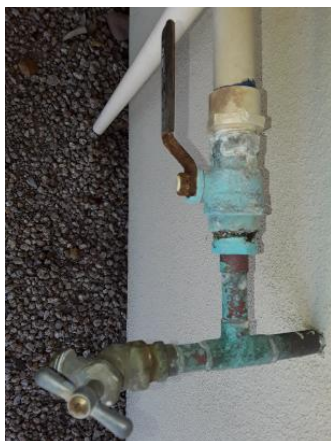
5.3 - The rear hose bib has a shut off valve which has evidence of corrosion. At one time it appears to have leaked but is not leaking right now. It needs further evaluation from a qualified contractor for service as determined necessary.

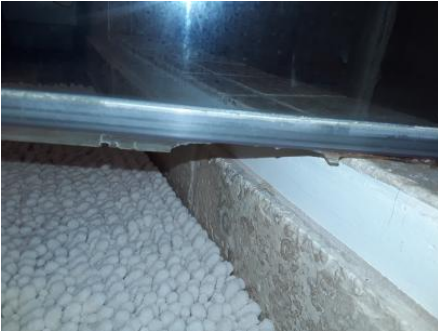
6.1 - The door sweep at the bottom of the glass shower door is damaged. This could allow water to escape the shower stall causing damage to walls and floors. I recommend further evaluation from a qualified contractor for more information and service as determined necessary.

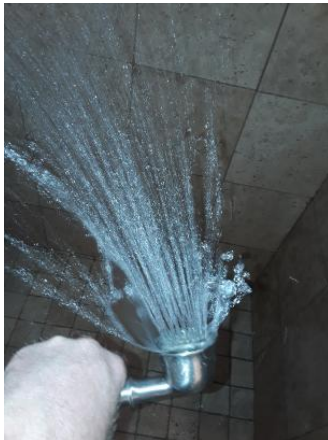
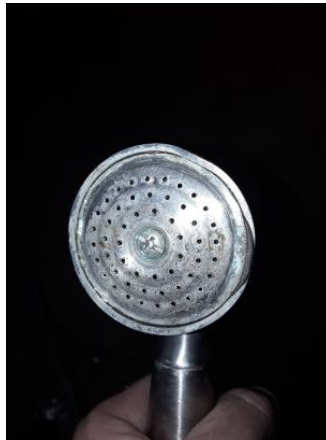
6.2 - The master bathroom shower wand leaks water out of the sides of the nozzle during use. It is designed to come out of the perforated holes only. It appears a gasket may have failed. I recommend further evaluation from a qualified contractor for more information and service as determined necessary.

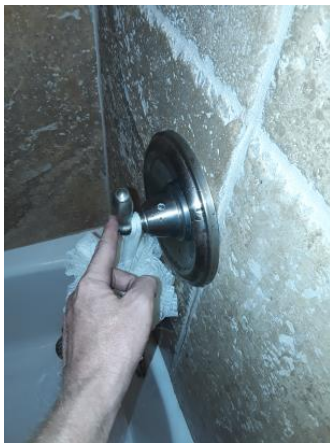
6.4 - The hall bathroom tub/shower valve handle is loose or not properly connected and should be serviced or replaced as necessary by a qualified plumber.

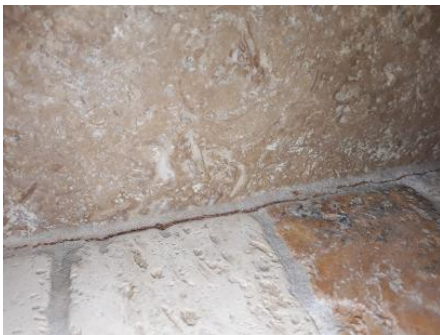
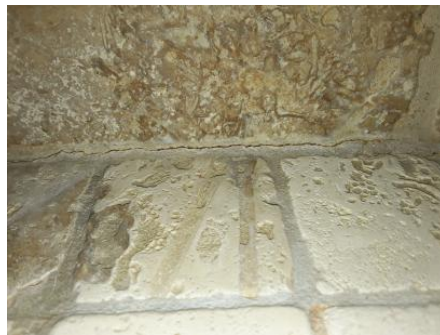
6.5 - There are open grout-joints where the floor meets the wall in the stall shower tiles that should be sealed to prevent moisture damage to the surrounding walls. Bathroom near garage door.

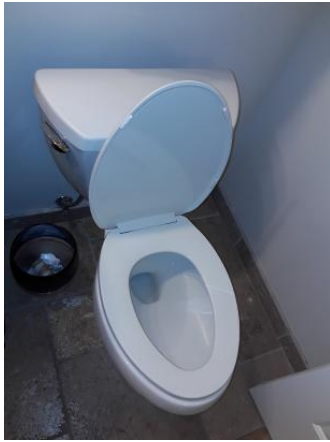
6.6 - The hallway bathroom toilet is functional, but loose on the floor and should be secured by a qualified contractor, for safety reasons and to prevent possible damage or leaking from around the toilet. Bathroom next to garage door.
